## XU Setup Fails if above COM31.

The issue occurs on windows 10 & 11 with port setup to COM42

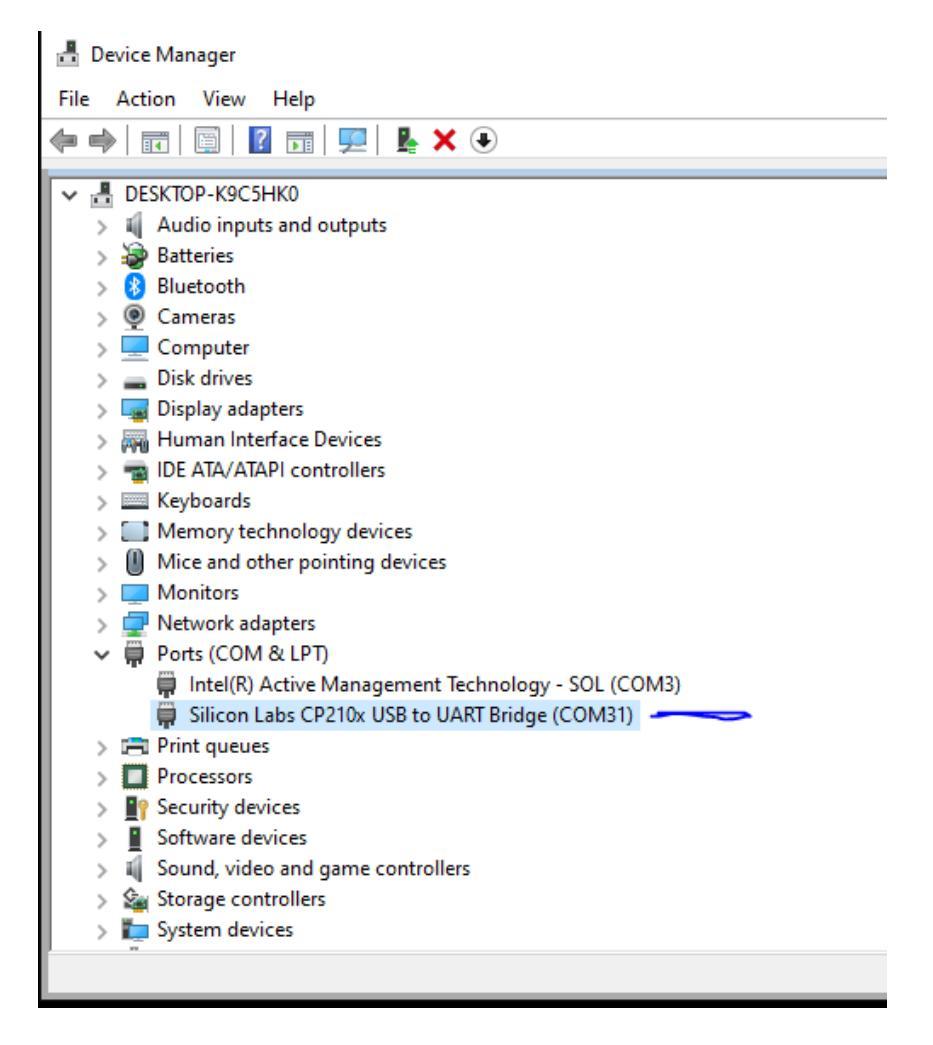
It appears that when the XU USB com port is set above COM31, XU setup will no longer connect to a transmitter.

To fix this issue please ensure that ports below COM31 are being used.

Access the Device Manager and find the settings for the XU Setup under ports.
